### Rapport om indsamling af miljødata ved udvalgte bropiller under Øresundsbron

**Biological Sampling**  
**(E25, E15, E01 and W01)**

**REPORT No. : ÖSB-4215-009-BS-01**

**Report**  
**Sampling of environmental data**  
**Öresundsbron**  
**Autumn 2003**

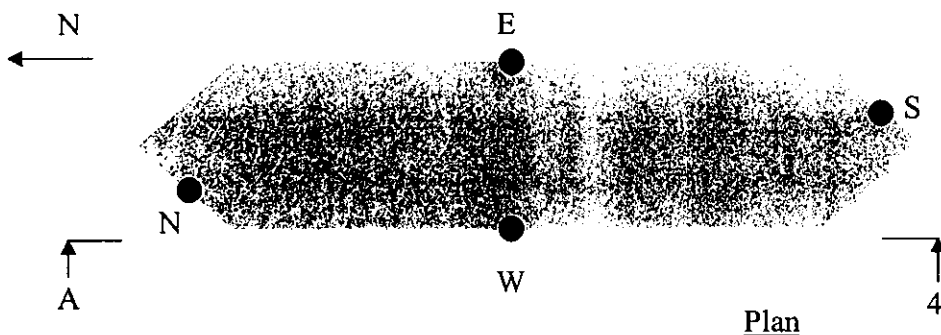
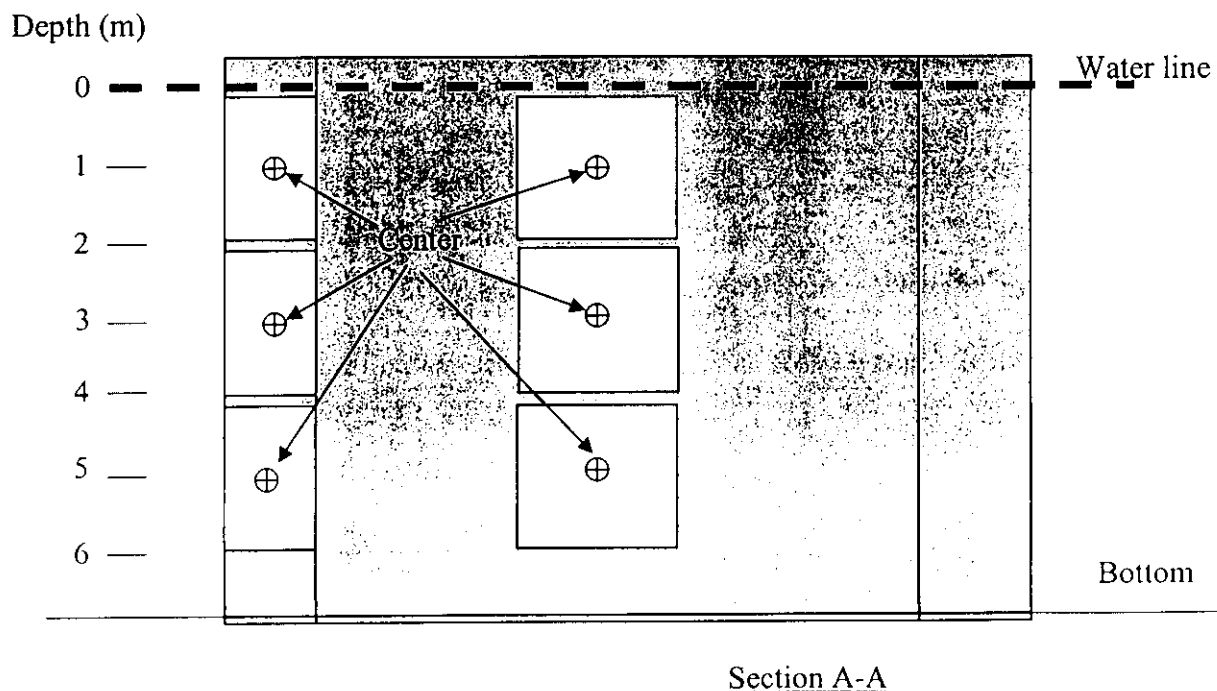
Before any measurements were taken a 2m x 2m area was marked out from the centre of the specified position by a diver.

The specified position was located in the middle of the pier's vertical face i.e. N, S, W or E and at the depth's specified by ÖSB's instruction dated 13<sup>th</sup> June 2003. (See below).

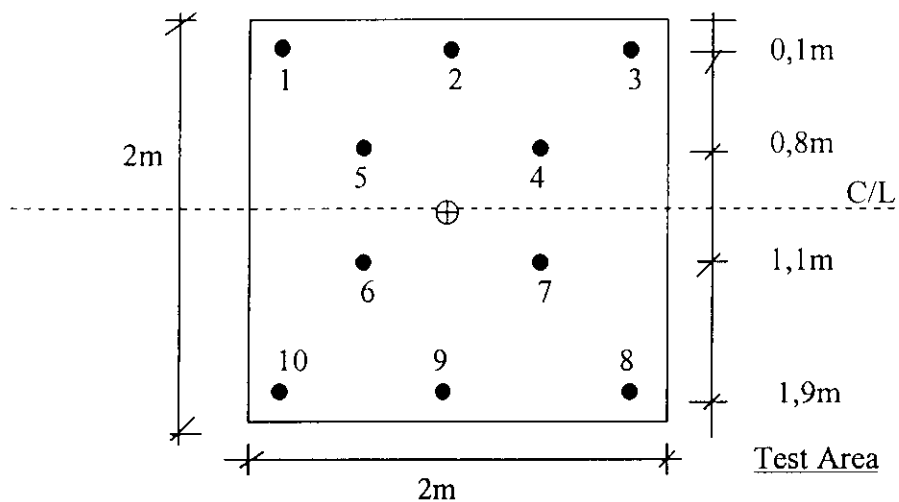
Each sampling area was representatively measured at 10 points evenly distributed across the entire sampling area to determine a mean value. The measurements were taken using a measuring stick of the thickness of the unsuspended organic material in chronological order. (See diagram below) The results were presented in the report table 4 in descending chronological order i.e.(1,2,3,4 etc.).

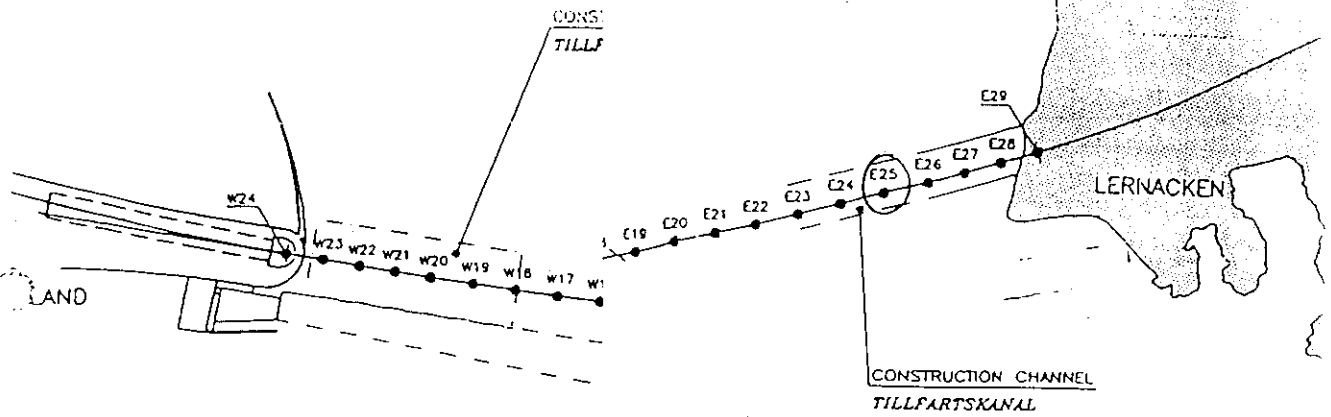
PLAN  
1:12500 (A1)

DEFINITION DRAWINGS - TYPE B BRIDGE  
BRIDGES CONTRACT  
POSITION OF PIERS
